T R I P R E P O R T

DATE: **September 13, 2010**
TO: **Alen Fetters, AIDEA/AEA**
FROM: **David Ausman, PE**
RE: **Five-Mile Creek Stream Flow Measurement Report, August, 2010**
CC: **Project File**

PROJECT
REGIONAL HYDROELECTRIC INVESTIGATION
CHITINA, ALASKA

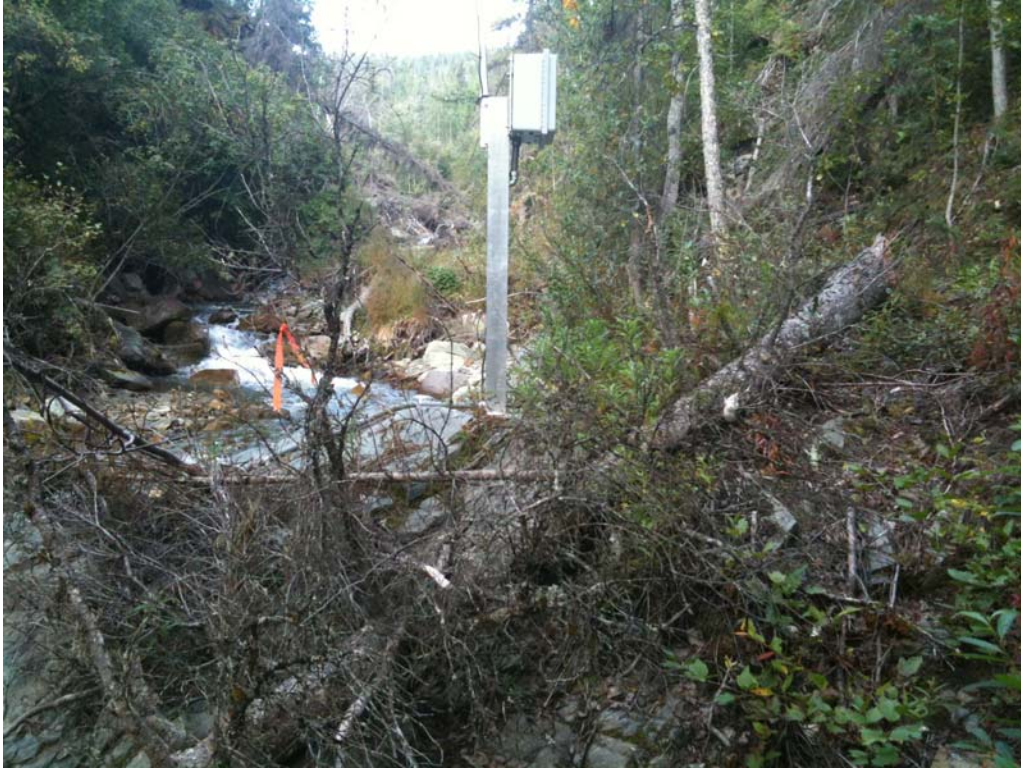
Inspection of the upper “intake” gauge site showed damage to the weir sections and a fallen spruce tree that had nearly struck the gauging equipment enclosure, photocell panel, cable, and stand (Photo 1). Upon closer inspection of the equipment, no signs of damage from the fallen tree was identified.

Photo 1. Upper “Intake” Gauging Site. Upstream view with fallen spruce tree in foreground and equipment post and enclosure in background.

Although the intake gauging station is operational, a replacement weir is required to allow continued stream flow measurement. The replacement weir needs to be constructed to withstand high flow events and damage resulting from ice movement. It is recommended that the surrounding beetle kill trees be felled to reduce the possibility of damage to the equipment.

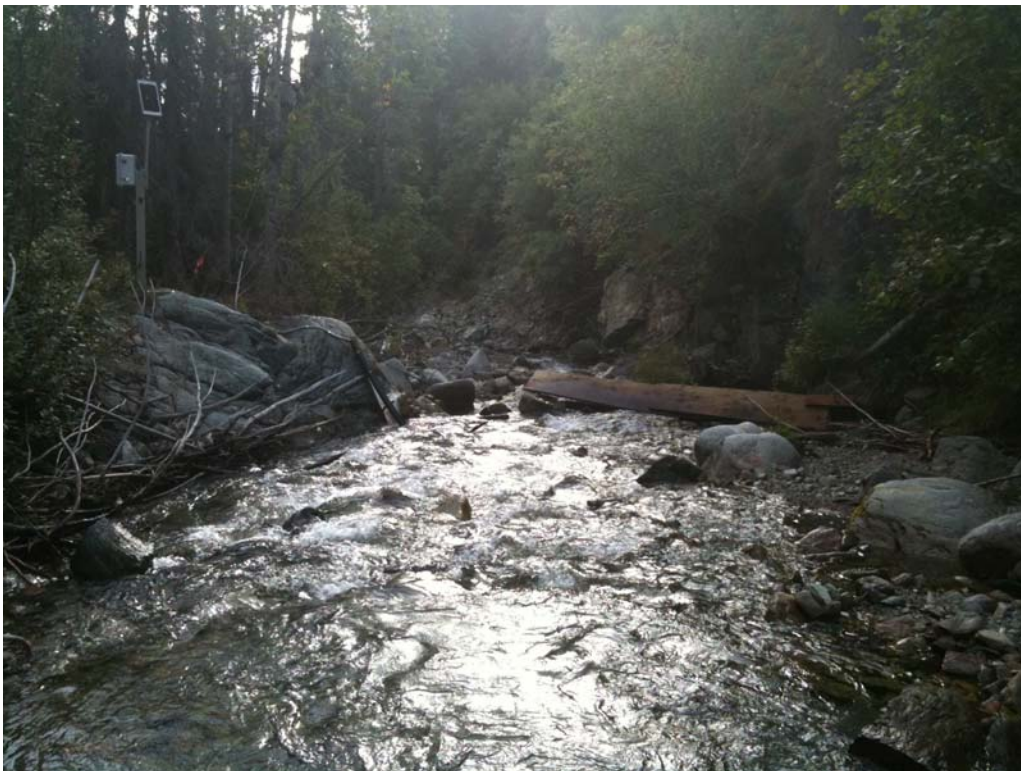
The weir that was constructed at the end of August 2009 was damaged as indicated by the displaced plywood weir sections. It is believed this damage occurred on March 3, 2010 during which ice and debris flows dislodged the weir from the stream bed. (Photo 2).

Data collected from the intake gauging site was sufficient to allow approximation of the seasonal low-flow event. However, as a result of the weir failure, the data following March 3, 2010 is unusable.

Photo 2. Upper “Intake” Gauging Site. Downstream view with weir sections in foreground and equipment post and enclosure in background.
